# Improving Flood Maps in Ungauged Fluvial Basins with Dendrogeomorphological Data. An Example from the Caldera de Taburiente National Park (Canary Islands, Spain)

**Abstract:** Flash floods represent one of the more usual natural hazards in mountain basins, and, combined with the lack of reliable flow data and the recreational use of the drainage basin by tourists and hikers, there is a significant risk of catastrophe. Here, we present a dendro-geomorphological reconstruction of a past flash flood event in the Caldera de Taburiente N.P. (Canary Islands, Spain), an ungauged drainage basin in the SW side of the volcanic island of La Palma. We couple two-dimensional hydraulic modelling in a highly-resolved topographic environment (LiDAR data) with (1) peak flow data for various  $T_{\text{year}}$  return periods from an uncalibrated hydrological model and (2) a data set of scars on trees, to investigate the magnitude of a 1997 dated flash-flood. From the results, flood hazards and associated risks would be clearly underestimated by using only the unique available hydrological data (a rainfall gauge station downstream of the study area). Hydraulic models using scars data show a highe

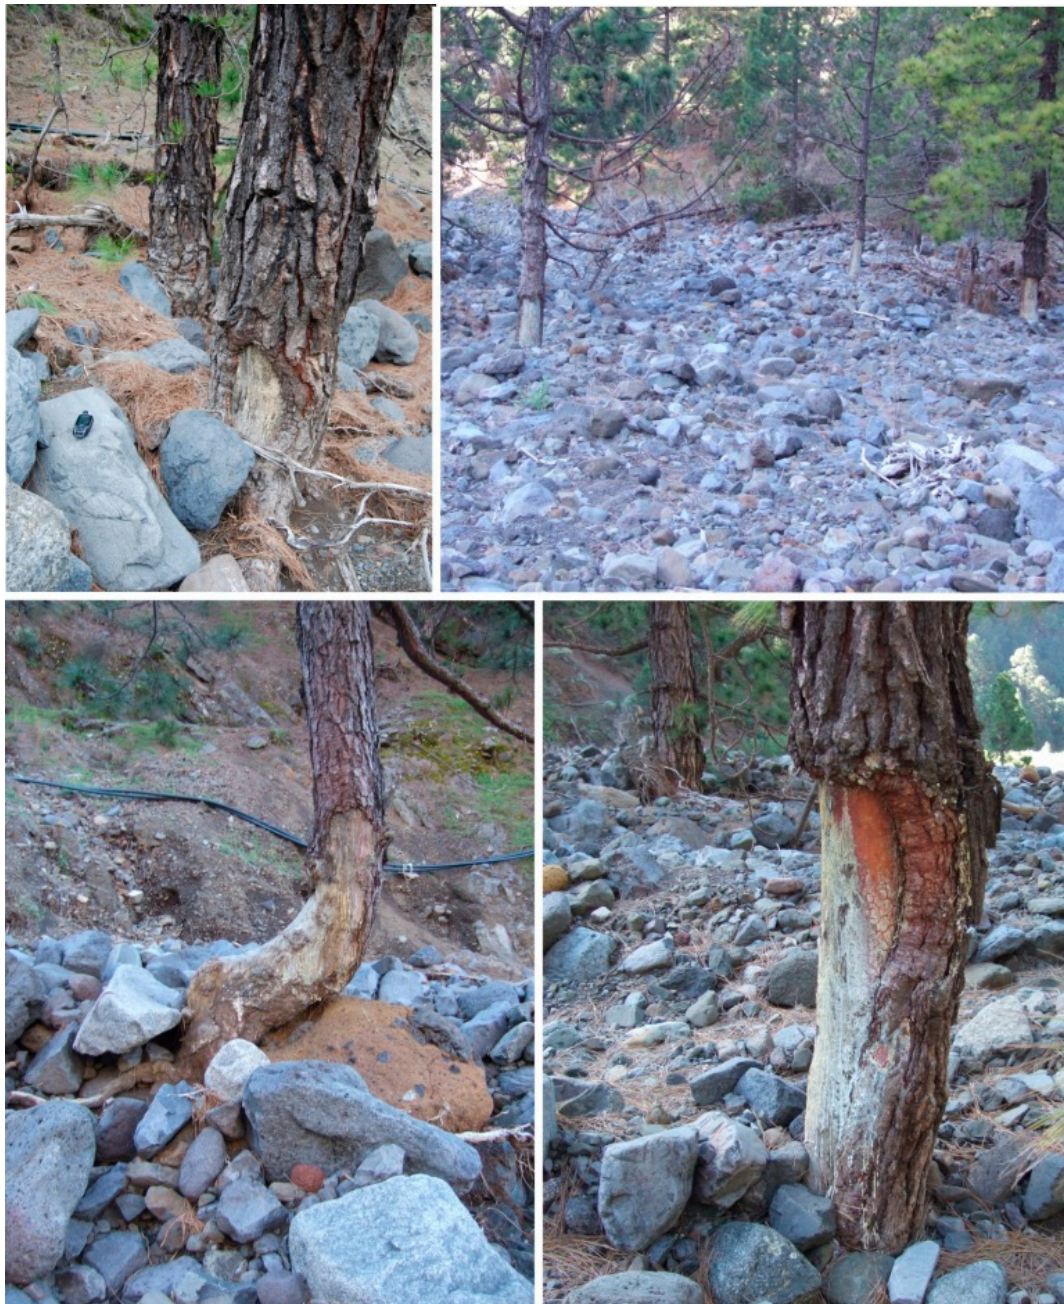
**Figure 2.** Mosaic images of some of the damaged trees during the 1977 flash-flood event in “Playa de Taburiente”.

Dendro-geomorphological fieldwork consisted of collecting samples of damaged trees (i.e., those presenting scars, exposed roots, resprouting, or apical bud loss and dead trees; Figure 2), other nearby trees with no visible injuries (as scars may have already closed if they are old or not very wide), and undamaged trees of *P. canariensis*. In some cases, trees showed several wounds corresponding to different events, but more often only one impact signal per tree was observed. Finally, we collected 233 samples from 60 disturbed trees and 37 samples from 16 undisturbed trees to provide a reference chronology [29].

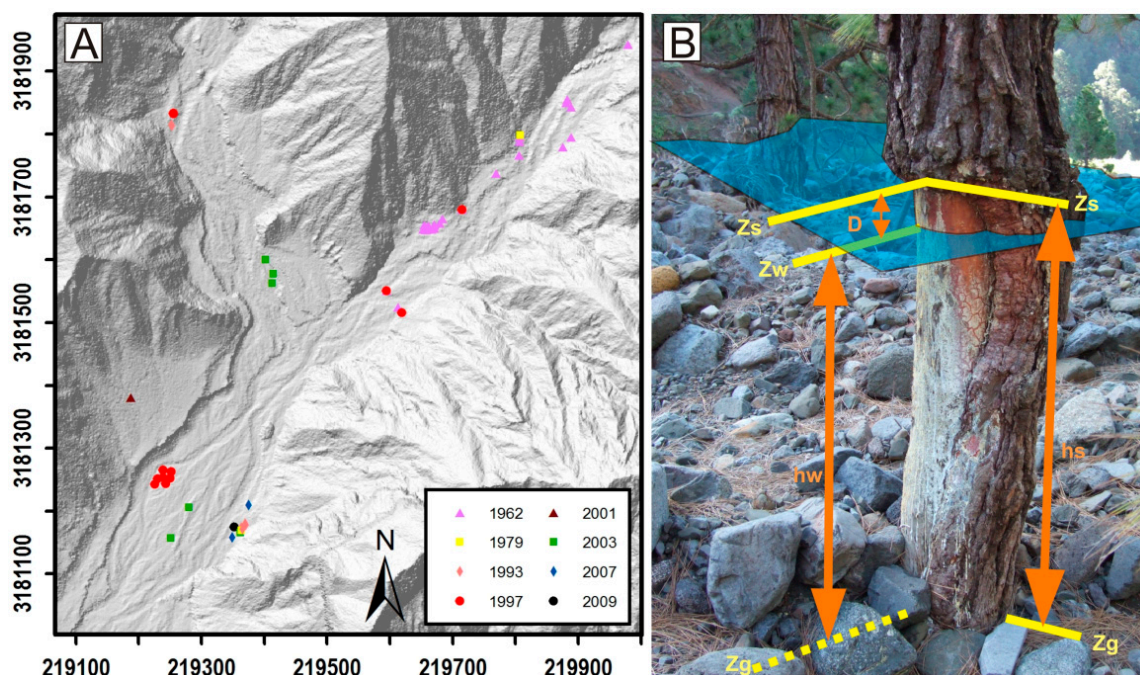
**Figure 3.** Map location of “Playa de Taburiente” dendro-geomorphological evidence (A); x- and y-axis units are meters, according to European Terrestrial Reference System 1989 (ETRS89). Dendro-geomorphological data of interest for hydraulic assessment (B).  $Z_s$ , scar topographic elevation;  $Z_w$ , water topographic elevation during event;  $Z_g$ , present day ground elevation;  $h_s$ , scar height;  $h_w$ , water depth during flood event regarding present day topography;  $D$ , height difference between scar and water surface (deviation).

Two or more increment cores (up to ten in some cases) were taken with an increment borer near the tree base if the scar was close to the ground or, more often, at breast height (approximately 1.30 m above the ground). At least one core was taken in the non-affected tissue, and one or more cores were extracted successively closer to the edge of the scar, until one core intersected the scar edge or showed a distinctive growth pattern to identify the year when the scar was produced [17]. In addition, some wedges were taken from the overgrowing callus with a handsaw, and whole sections were cut from two dead trees. Each sampled tree was recorded in a spatial database with additional information including (i) scar size and other evidence of disturbance; (ii) tree height, tree diameter at breast height (DBH), and other parameters (Figure 3); and (iii) sketches, drawings, and photographs.

63 wounds were dated, in some cases more than once for each tree. Especially relevant were the injuries occurring in 1962 and in 1997 (Figure 3), both presenting a large number of replications (48% and 22%, respectively, of the total number of trees). Wounds dated to 1993 and 2003 were, respectively, found in 23% and 20% of the younger trees. Over the last decade, injuries have been dated to 2001, 2003, 2007, and 2009, which together account for 18%. Other anomalies in the samples were also found with evidence of injuries but were not reliably dated [29].

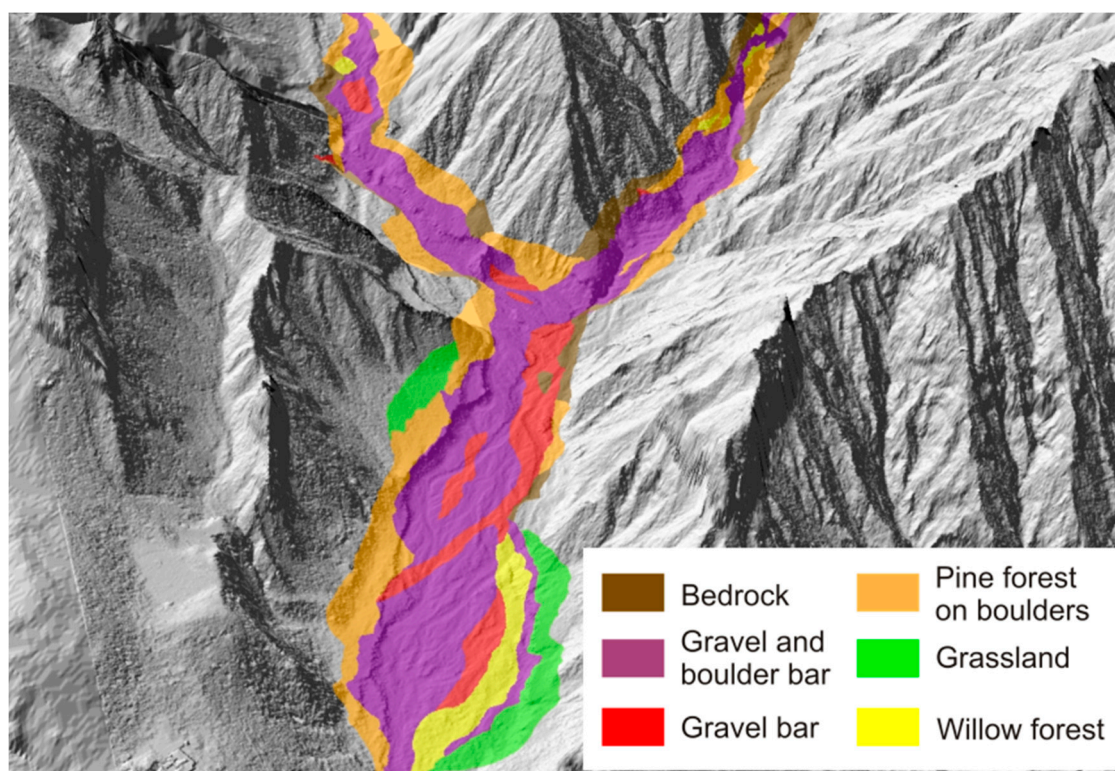
**Figure 4.** Generated 3D mesh for hydraulic simulation of floods (Iber software). Terrain roughness ( $n$  Manning coefficient) map is overlapped to mesh to allow identification of homogeneous areas. Surface roughness classes and associated coefficients are bedrock ( $n = 0.04$ ), gravel and boulder bar ( $n = 0.055$ ), gravel bar ( $n = 0.035$ ), pine forest on boulders ( $n = 0.05$ ), grassland ( $n = 0.035$ ), willow forest ( $n = 0.07$ ), and disperse vegetation ( $n = 0.06$ ).

The last boundary condition of the model to note is the surface roughness of the terrain, expressed by the Manning  $n$  coefficient. This variable was derived from the photointerpretation of 0.5-m spatial resolution aerial orthoimages and with field work. Different areas with homogeneous relief roughness and vegetation density were defined, and the corresponding Manning’s  $n$  value (Figure 4) was assigned to them following the most common tables and graphic guides [36,37]. Due to the flash flood event date, other approaches to generating surface roughness maps using satellite images [38] were not feasible due to the low spatial resolution of the images (the channel width was covered by only 3–5 pixels). Two surface roughness terrain models were developed in order to analyse the model sensitivity to Manning roughness coefficients, due to the absence of high resolution orthoimages (pixel size lower than 0.5 m) for the 1997 flash-flood event. Orthoimage dates used for sensitivity analysis were 2002 (the date closest in time to the flood event) and 2013 (the most current orthoimage for the study area). This sensitivity analysis allows us to check the possible influence of surface roughness variations over time in peak flow generation.

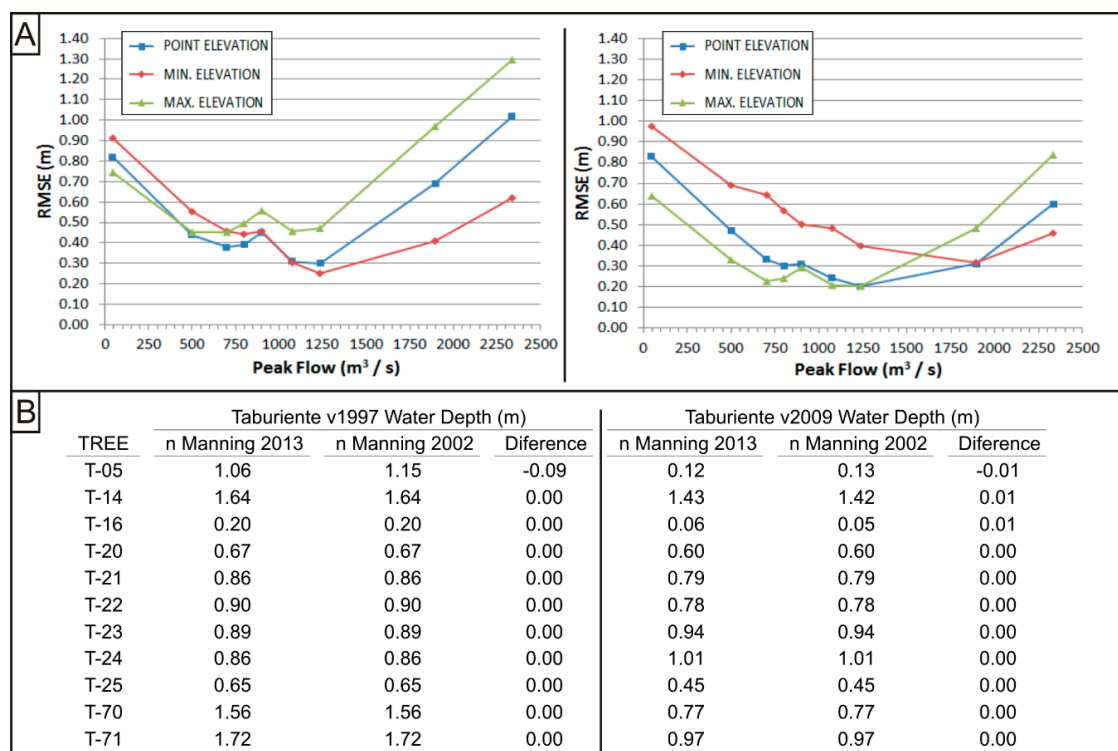
**Figure 5.** (A) Flow depth value for different modelled flows vs. the heights of the dendro-geomorphological evidence: results from the v2009 DEM (left) and v1997 DEM (right); (B) flow depth value difference on tree location due to surface roughness change sensitivity analysis.

The first attempt at hydraulic simulation was carried out from the flows obtained in the hydrological model that used the precipitations registered at the station C106U for the three days between 11 and 13 January 1997. It soon became clear that the  $Q_{pm}$  (peak flow value minimizing the RMSE) exceeded the  $Q_{r-r}$  (peak flow range value derived by rainfall-runoff transformation [28] for this event). The RMSE value refers to the fit error between the heights of the scars (dendro-geomorphological evidence, FDEs) and the water surface height associated with flood modelling in those locations. To determine this peak flow value, a simulation was then run using the estimated 500-year return period discharge value as the second peak flow value. The results of the modelling continued to show a high RMSE, and the variable flow depth obtained was always below the variable scar height. From these results, simulation using different increasing peak flow values was developed until a lower limit value of the RMSE was obtained. This value was established (Figure 5A) as a peak flow of  $1235 \text{ m}^3 \cdot \text{s}^{-1}$ , and it does not appear to be driven by topographic and surface roughness variables, as the sensitivity analysis results show (Figure 5).

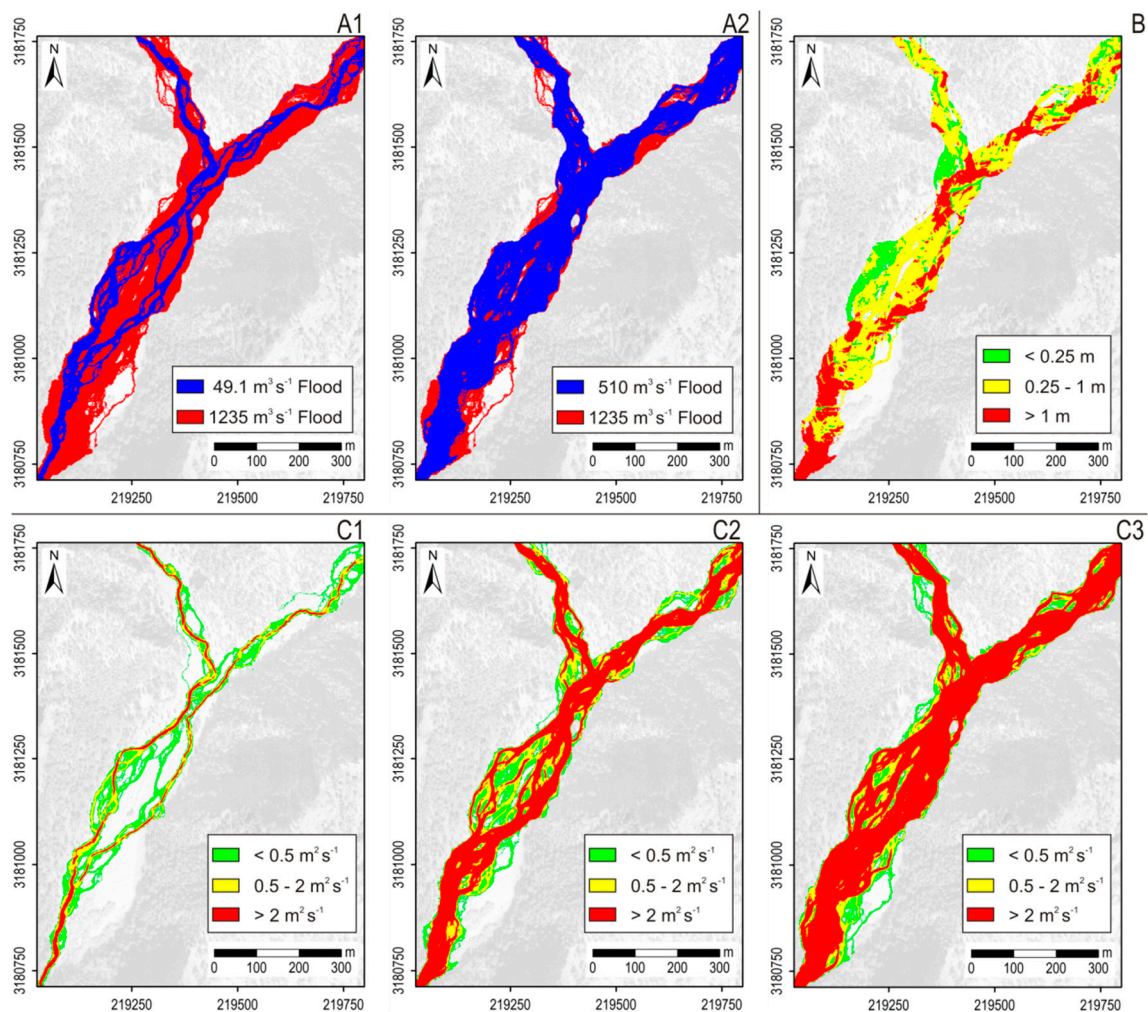
**Figure 6.** Hydraulic model outputs. Water surface extension (A1) associated both 11–13 January 1997 precipitation event ( $49.1 \text{ m}^3 \text{ s}^{-1}$ ) and liquid flow rate ( $1235 \text{ m}^3 \text{ s}^{-1}$ ) with the lowest RMSE value in the comparison between the water surface heights and tree scar height (dendro-geomorphological evidence). Water surface extension (A2) associated both 500-year return period rainfall (24-h duration hyetograph),  $508 \text{ m}^3 \text{ s}^{-1}$ , and  $1235 \text{ m}^3 \text{ s}^{-1}$  peak flow (lowest RMSE between water surface height and dendro-geomorphological evidence). (B)  $1235 \text{ m}^3 \text{ s}^{-1}$  and  $508 \text{ m}^3 \text{ s}^{-1}$  differences in water depth results. (C) delimitation of risk areas where people may suffer loss of stability due to flow, for different peak flows ((C1),  $49.1 \text{ m}^3 \text{ s}^{-1}$ ; (C2),  $508 \text{ m}^3 \text{ s}^{-1}$ ; and (C3),  $1235 \text{ m}^3 \text{ s}^{-1}$ ). X- and y-axis units are meters, according to European Terrestrial Reference System 1989 (ETRS89)

In addition, these flow differences mean a distinct behavioural change in this gorge. As shown in Figure 6(A1), it functions either as a braided channel with emerged bars ( $\sim 50 \text{ m}^3 \text{ s}^{-1}$ ) or as a single channel occupying the whole river bed ( $\sim 1200 \text{ m}^3 \text{ s}^{-1}$ ). The difference in channel behaviour is less evident (Figure 6(A2)) if we compare both the peak flow obtained using dendro-geomorphological data height ( $1235 \text{ m}^3 \text{ s}^{-1}$ ) and that associated with the 500-year return period ( $510 \text{ m}^3 \text{ s}^{-1}$ ). In these cases, a single channel occupying the whole river bed is the main river shape. However, significant flow depth differences can be observed between the hydraulic models, which range from 0.25–1 m in the area of “Playa de Taburiente”. Water depth differences (Figure 6B) for the entire area covered by the hydraulic model show an average value of 1.2 m. However, this number is clearly affected by the values calculated for the narrower sections of both gullies. For the flow velocity data, the differences obtained between the hydraulic models with  $1235 \text{ m}^3 \text{ s}^{-1}$  and  $510 \text{ m}^3 \text{ s}^{-1}$  peak flows have an average value of 2.6 m/s, although in this case, as with the water depth, the average value is affected by the flow velocities reached in those narrower sections of the gullies, with the average flow velocity in the area of “Playa de Taburiente” being around  $2.2 \text{ m s}^{-1}$ .

suffer loss of stability due to flow [39,40] will be of great importance for Park management. The results from the hydraulic models (Figures 6(C1–C3) and 8) show large differences in relation to the high-risk area. Thus, in the  $50 \text{ m}^3 \text{ s}^{-1}$  peak flow model, the high-risk areas in the “Playa de Taburiente” are small and are limited to the most developed river channels within a braided channel pattern. In the  $510 \text{ m}^3 \text{ s}^{-1}$  peak flow model, the high-risk zones are much larger, with all of the channels and the lower bars included in the high-risk zone. Finally, in the  $1235 \text{ m}^3 \text{ s}^{-1}$  peak flow model, the high-risk zones cover about 85% of the bottom valley area, defining a main central channel with considerable secondary channels on each side.

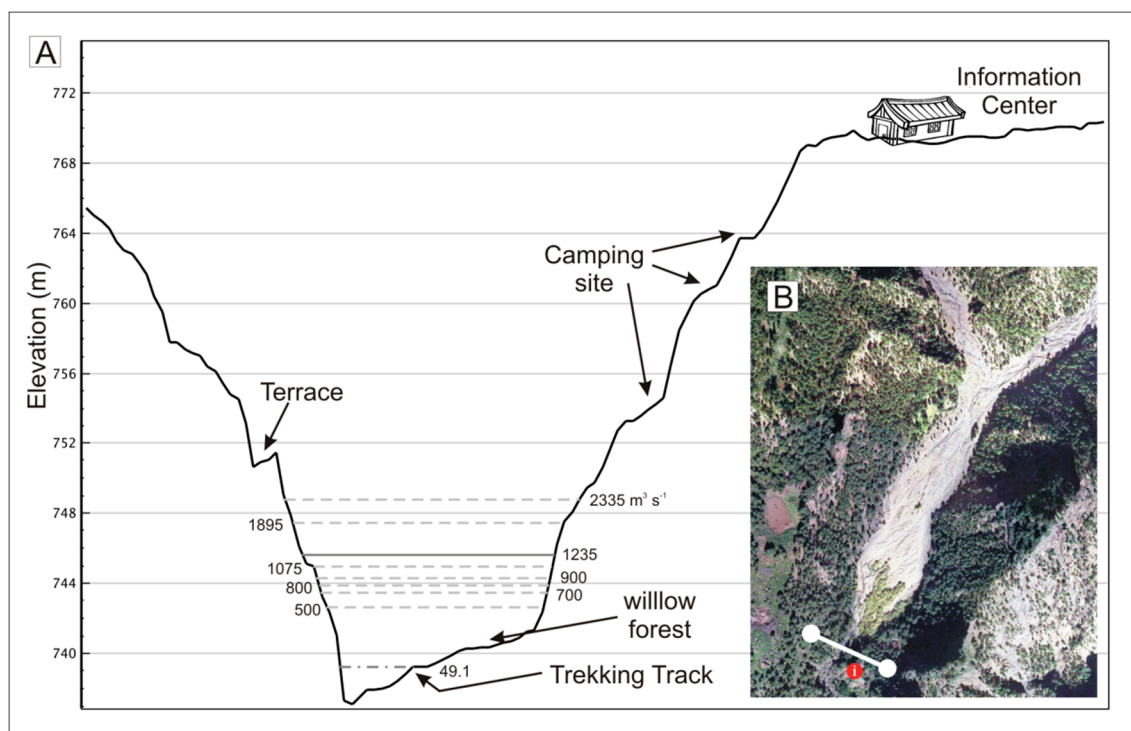
**Figure 7.** Flood stage graphic near the Information Centre of the Caldera de Taburiente National Park. Shown (A) flood stage associated to recorded rainfall during 1997 event ( $49.1 \text{ m}^3 \text{ s}^{-1}$ ; dashed—dot line), flood stage for  $\text{RMSE}_{\min}$  relative to water surface—scar evidence height ( $1235 \text{ m}^3 \text{ s}^{-1}$ ; solid line), and other modelled flows (dashed lines). (B) Location of the cross section (white line) associated with flood stage values, and Caldera de Taburiente National Park Information Center.

The last point is of great importance in flood risk assessment and for generating the relevant mapping to determine the zones affected, or unaffected, by flash floods (Figures 6(C1–C3) and 7). For example, taking into account the particular characteristics of the study area (a National Park with a large influx of hikers, over 60,000 people per year), the delimitation of risk areas where people could

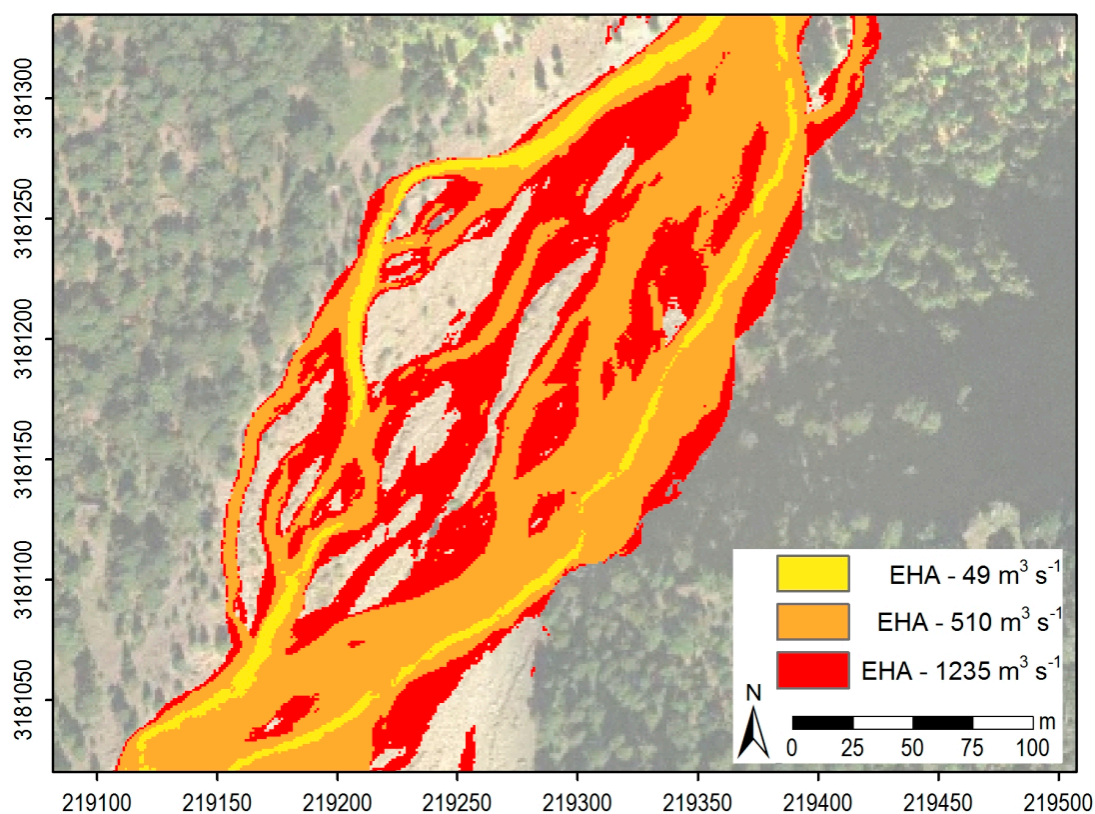
**Figure 8.** Extreme hazard areas (EHA, where:  $v \times d > 2 \text{ m}^2 \text{ s}^{-1}$ ) for people by loss of stability due to flow; each colour area is associated with a different peak flow hydraulic model. X- and y-axis units are meters, according to European Terrestrial Reference System 1989 (ETRS89)

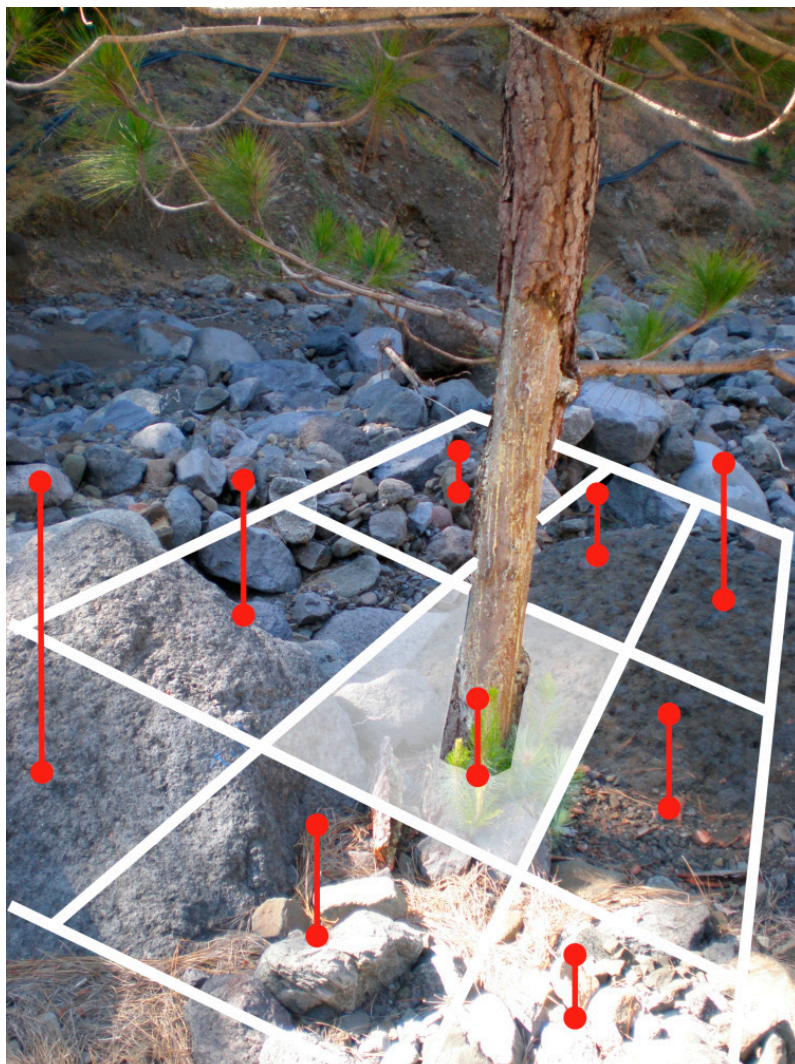
**Figure 9.** Sketch of the buffer approach followed for the sensitivity analysis of the peak flow estimation results against the location of dendro-geomorphological evidence. Red lines show the elevation variability inside the buffer area.

Another source of uncertainty which cannot be ignored refers to the spatial distribution and location of the disturbed trees, which were located through a topographic survey. However, due to the abrupt relief of the area, any minimal displacement or uncertainty in the real location of the disturbed trees may produce significant differences in its topographic elevation. Therefore, these minimal displacements may similarly produce significant differences in hydraulic results. To limit this uncertainty when analysing the match between the height of the disturbances and of the water sheet, a  $3 \times 3$  m buffer was taken into account around the position of the disturbed tree (Figure 9), and its 9 elevation values were used. The results obtained lead to the following conclusion: although the associated RMSE values (Figure 5A) vary according to the topographical values used inside the buffer (minimum, maximum, and tree location values), these do not modify the peak flow value associated with the lower RMSE.
